## BELZONA RESTORES FELT RETURN ROLL

Paper mill in the south of England

Felt return roll.

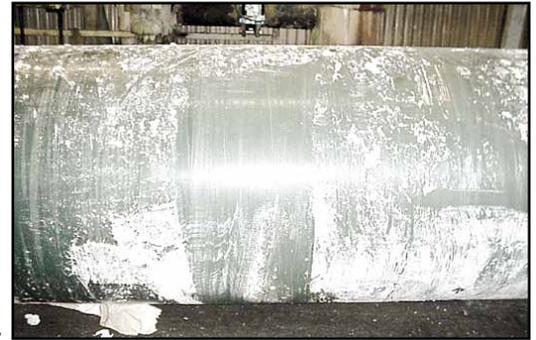
The fiberglass roll coating had worn to such an extent that the fibrous reinforcement was protruding from the surface of the coating, allowing water to ingress into the coating.

1. Previous coating showing signs of wear
2. Applying Belzona® 1321
3. The roll in service on the paper machine
