BELZONA INJECTS NEW LIFE INTO HYDRO DAM BEARING

Hydroelectric plant, Missouri

February 2012

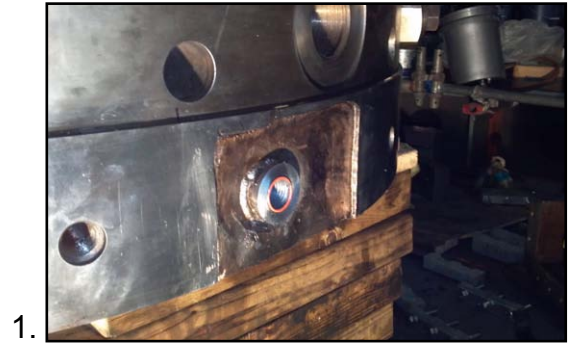
While running a high voltage test on the bearing and isolator ring a section of the bearing was damaged when a spark melted one area.

1. Close up of the damaged surface
2. Mold being treated with release agent
3. Injecting the Belzona® 1321
4. Completed repair
